The *Alexander L. Kieftand* Accident

Proceedings from
The First Robert Bruce Wallace Lecture
Department of Ocean Engineering
Massachusetts Institute of Technology

Lecturer
Professor Torgeir Moan
The Norwegian Institute of Technology
Trondheim

28 April 1981

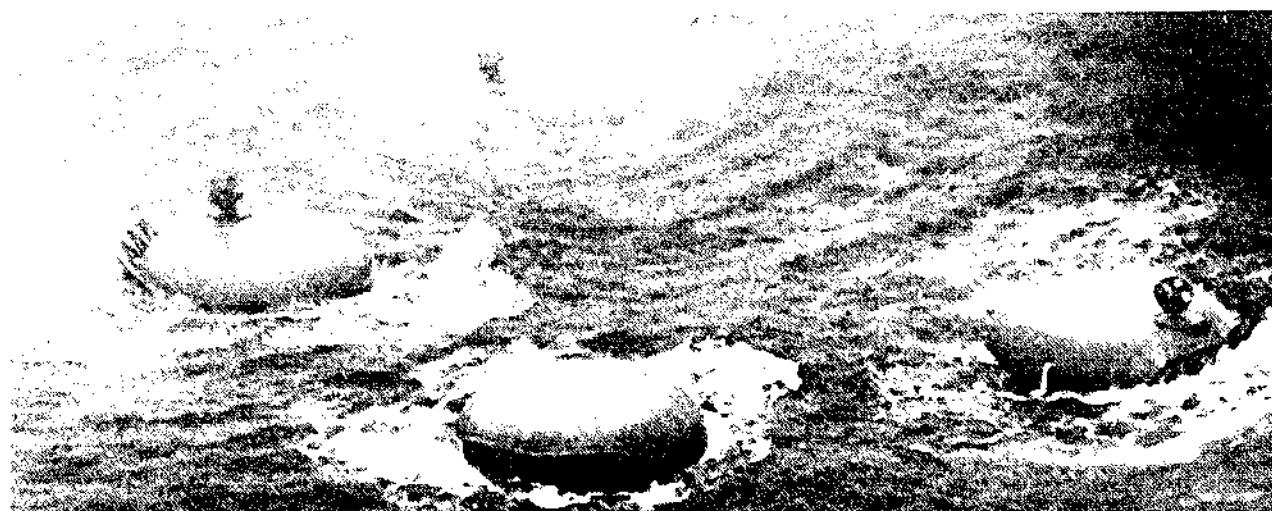
On March 27, 1980 at about 6:30 pm, one of five columns broke off the hotel platform the *Alexander L. Kjølland*. The platform heeled over. When flooding of the buoyancy chambers started, the platform continued to heel and sink. After about 20 minutes, it capsized. See Figure 1. Out of the 212 men on board, 123 lost their lives.

Figure 1
The *Alexander L. Kjølland* after the accident.

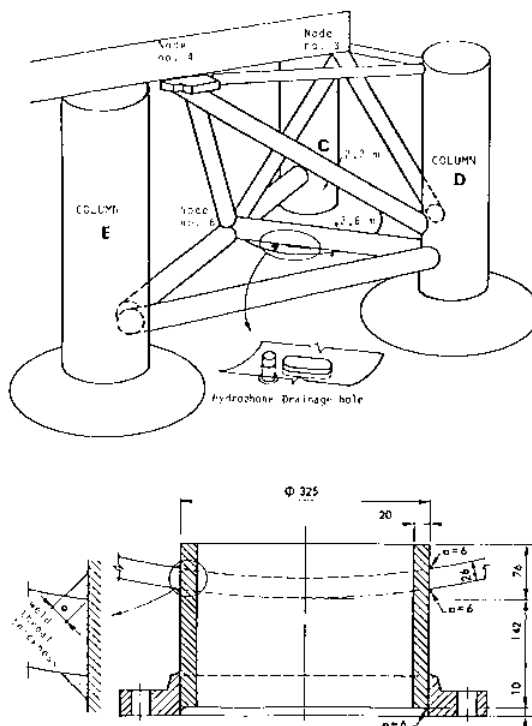
Figure 3a
Location of the hydrophone on bracing D-6 of the *Alexander L. Klelland*.

Figure 3b
Hydrophone support on the bracing D-6 of the *Alexander L. Klelland*.

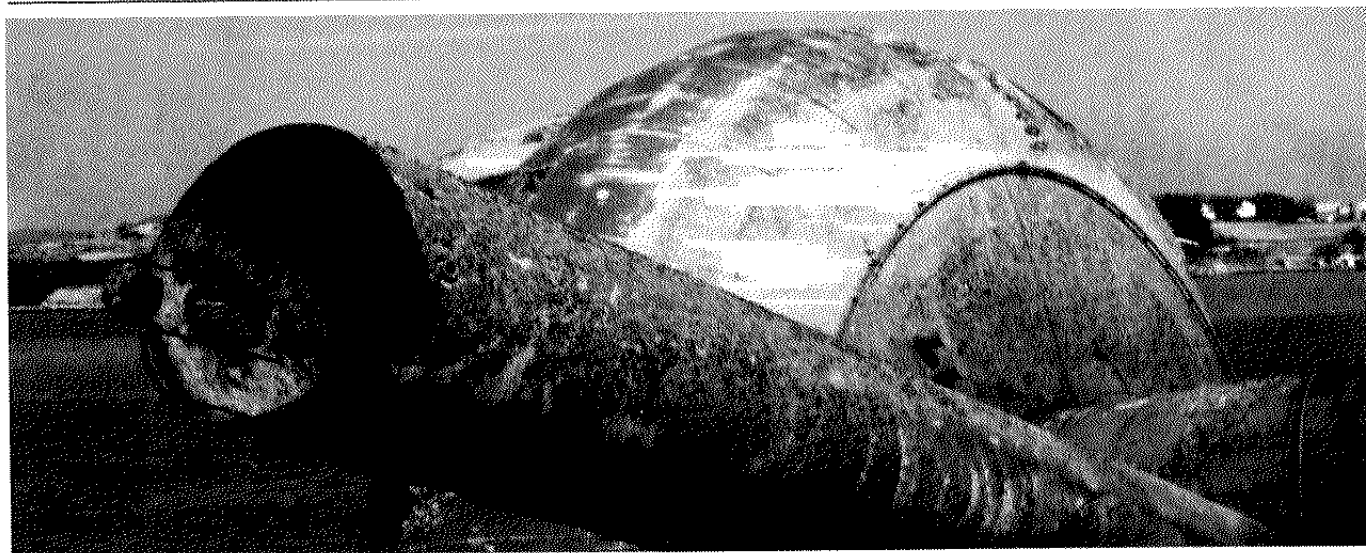
Figure 6
Pontoon - column D
with a part of the bracing D-6. Cracks in the
bracing and the joint
between the hydro-
phone support and the
bracing.

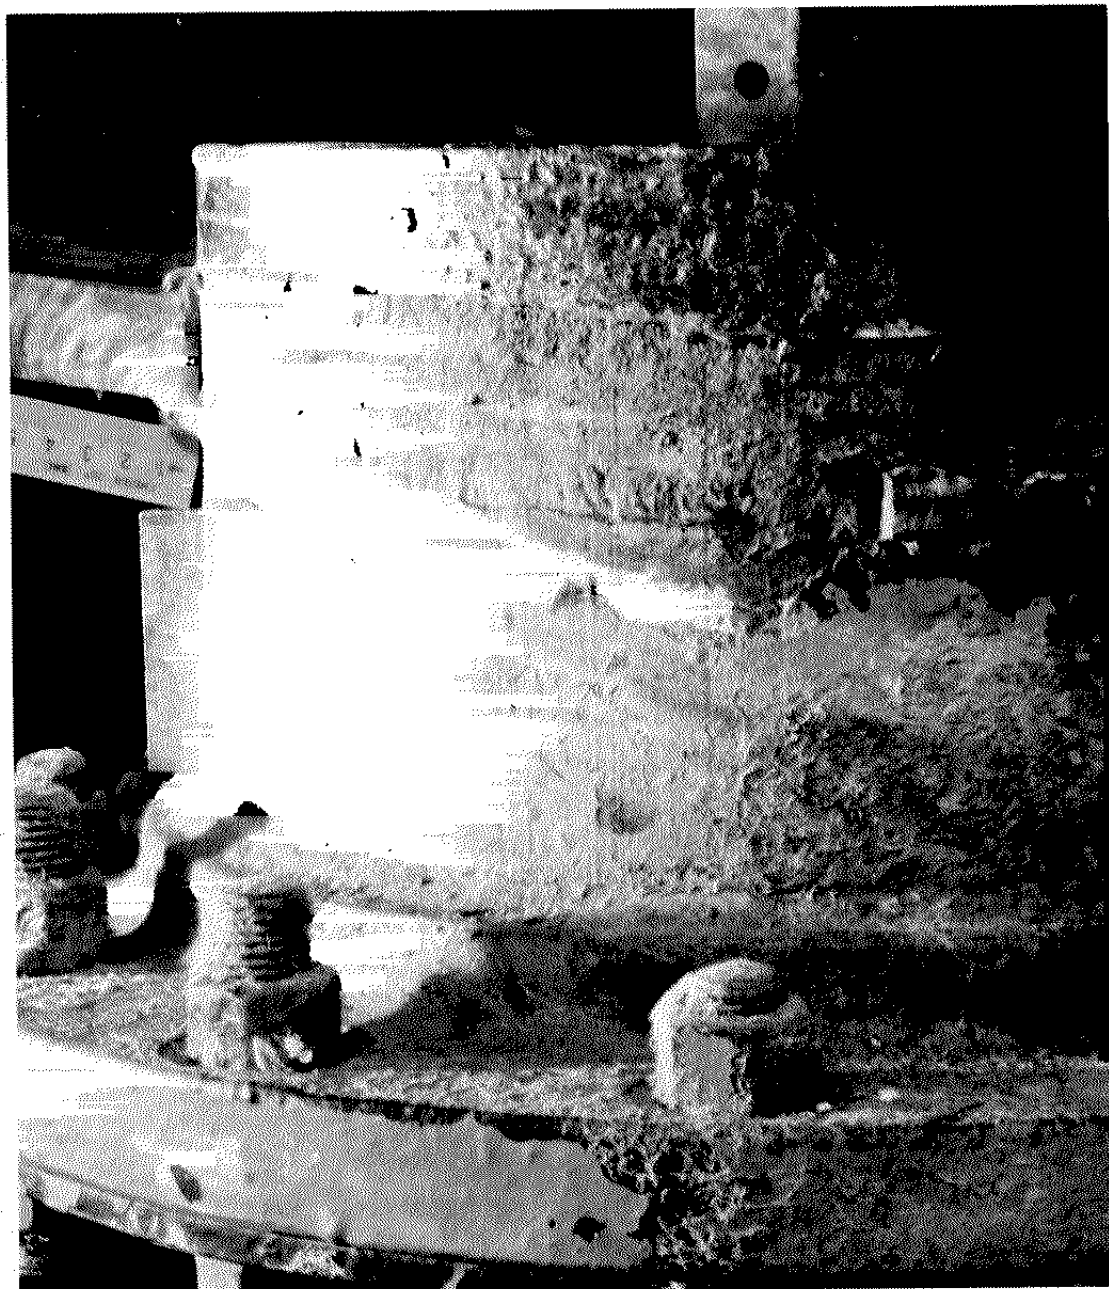
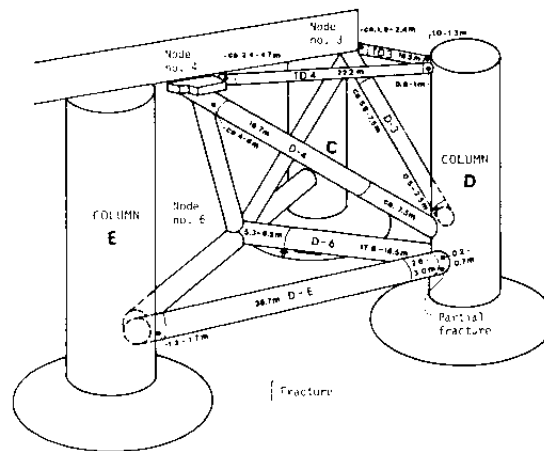
Figure 5
Location of fractures in
the bracings of the
Alexander L. Klelland.

First, bracing D-6 broke off. Then, in rapid succession, the five other bracings, which connected column D to the platform, failed from overloading. Figure 5 shows the approximate location of the fractures. Figure 6 illustrates the features of the fractures in the D-6 bracing.

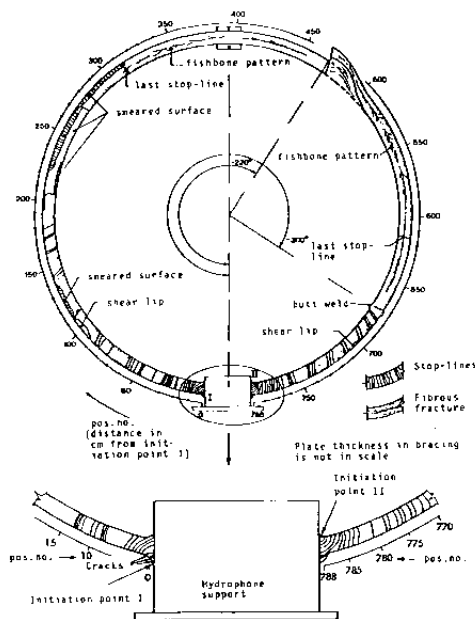
The fracture in bracing D-6, which initiated the structural failure, was caused by fatigue. Figure 7 displays a sketch of the most significant macroscopic features of the fracture surface. The so-called stop-lines, which are typical for a fatigue failure, show where the crack front had stopped, or progressed slowly, at different times. It is noted that the hydrophone support is located in the fracture cross section. The hydrophone support tube was joined to the bracing by two fillet welds. Fractures had also occurred in, and adjacent to, these welds over most of the circumference of each. See Figures 8 and 9.

Figure 7
Sketch of the fracture
surface of bracing D-6.

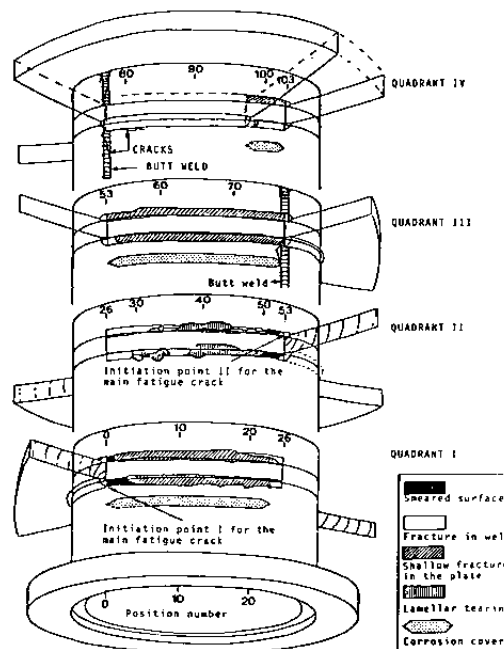
Figure 8
Sketch of the fracture
surface of the joints
between the hydro-
phone support and the
bracing.

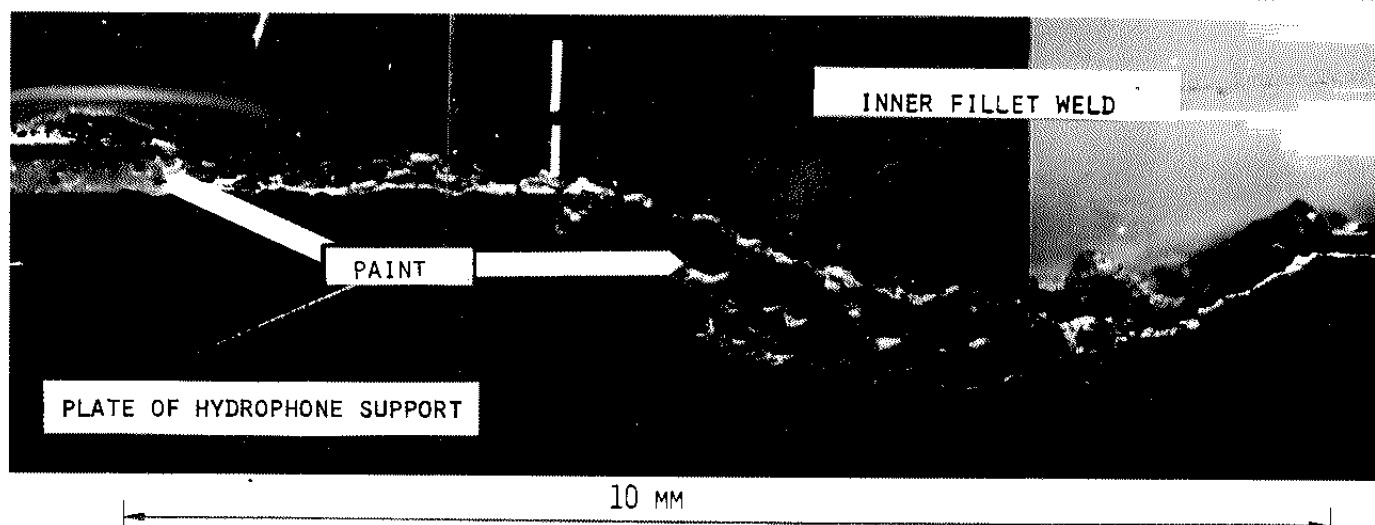
Figure 10
Longitudinal cross-section of the plate of the hydrophone support. Paint on the fracture surface.

Investigations after the accident revealed a less than satisfactory shape for the fillet weld beads. At the same time, penetration through the hydrophone support plate was rather small. Low strength and ductility in the direction of the plate thickness of the steel material and inferior quality of the fillet welds, together with a high stress level in the welds, resulted in fractures in the welded connection between the hydrophone support and the bracing, and in the hydrophone support itself. Some of the fractures must have developed before the platform was mounted. The paint residue (see Figure 10) found on fracture surfaces is one proof of this. The residue originates from painting done during construction in the Dunkerque yard. The detection of paint proves that at the fabrication stage there was a crack of at least 70mm length on the inner fillet weld. Further cracking occurred as shown in Figure 11 early in the operation of the platform.

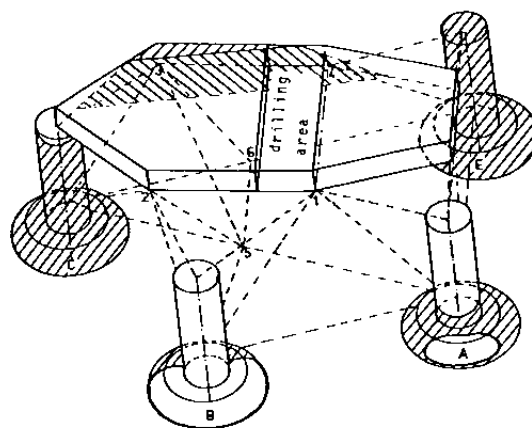
The fractures in the joint between the hydrophone support and the bracing resulted in a stress redistribution. As a result, two diametrical points in the bracing of the hydrophone support opening were subject to higher loading than before. With the rough fracture surfaces, this initiated fatigue cracks in the bracing itself at these two points. From both points, the crack developed along the circumference of the bracing. The bracing was weakened to such an extent that it could no longer withstand the loads to which it was exposed. When the final crack occurred, about two thirds of the circumference of the bracing was split. The cracks appeared to have grown through the plate thickness of the bracing, no more than 12 months before the final crack. It is possible, however, that this final cracking developed in a substantially shorter time.

Figure 11 (left) Probable crack development in the joint between the hydrophone support and the bracing. Phase 1. Crack proved to have occurred during fabrication. Phase 2. Probably cracks at a relatively early stage.

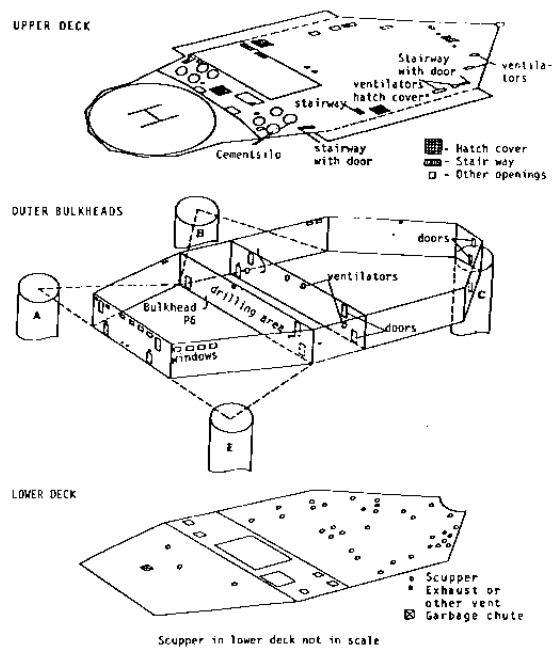
In addition, deficient compliance with instructions for closing appliances contributed to the serious consequences of the accident. The unsecured openings rapidly filled with water in the deck. This reduced the time in which the rig remained in a position that allowed personnel to stay on board to be rescued. Instead many had to jump into the sea. The chances of surviving for more than half an hour in the cold water proved to be minimal.

Figure 13 Openings in the outside bulkheads and decks in the *Alexander L. Kiehlund*.

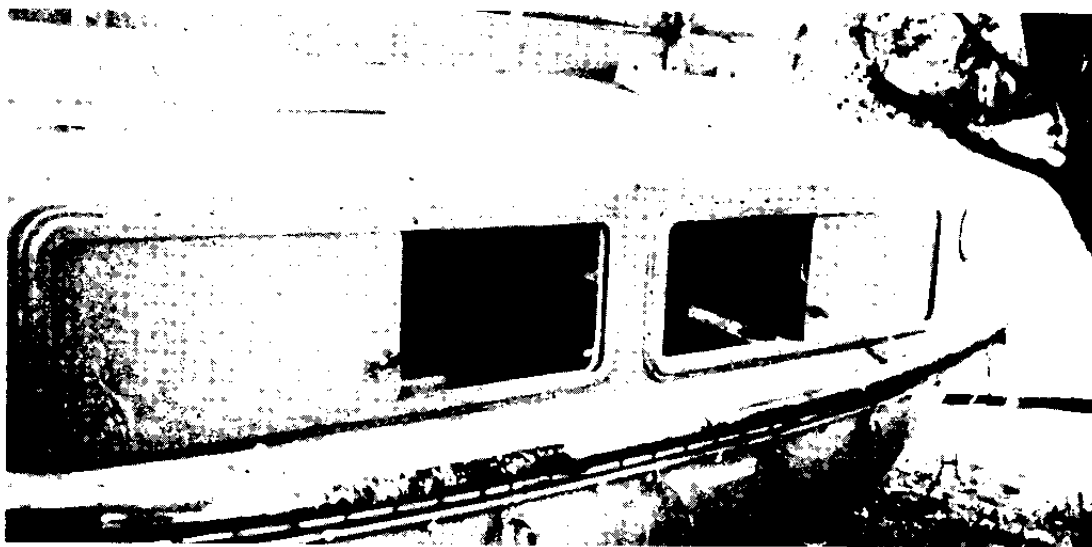
Figure 19
Starboard side of lifeboat number 5. Nineteen men were pulled from the sea and in through the open hatches.

The only recommendations given for improvement of existing lifesaving appliances is concerned with lifeboats. In the actual accident it was the releasing mechanism of the lifeboats which failed. This releasing system will not necessarily be improved by the introduction of lifeboat hooks which can be released while under load. Experience from a previous accident shows that evacuees may panic and could release the life boat at too high a level above the sea. The Commission, therefore, recommends an intensified effort to improve releasing mechanism or to develop another launching arrangement. In the meantime, the existing equipment should be improved. For example, the cover plates fitted around the releasing hook should be strengthened to prevent the plates from bending and blocking the releasing hook. Further, the Commission proposes a number of improvements for equipment and supplies. For instance, clothing and woolen carpets should be included onboard lifeboats; the outside of the super-structure and the bottom of the boats should be fitted with reflectors.
